Microtunneling in Mixed Face/Mixed Reach Hard Rock

Lester M. Bradshaw, Jr., President
Bradshaw Construction Corporation
Eldersburg, Maryland

Bradshaw Construction Corporation recently completed a microtunnel drive that crossed the Schuylkill River in Reading, Pennsylvania. The project consisted of 436 feet of 60 inch steel casing with an average depth of 35 feet at the shafts. Ground cover under the river was as little as 5 feet. Mining conditions began with a mixed face of non-cohesive gravel in the top of the heading overlaying fractured dolomitic rock at the bottom. The heading transitioned to a full face of fractured dolomitic rock approximately half way in to the drive. The rock had unconfined compressive strength (UCS) values of up to 34,300 psi. This paper discusses the challenges associated with the project, including limited work space, rock excavation in the shaft and tunnel, disc cutter wear and changes, managing the water table, and receiving the MTBM in a 9 foot ID drilled shaft.

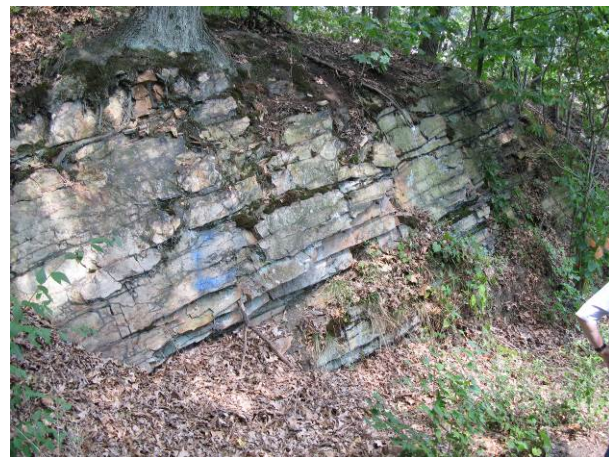
Figure 2: Representative Rock Outcrop

The jacking shaft on the north side of the Schuylkill River was shown to be in fill and alluvial deposits, well above the underlying weathered limestone. The receiving shaft on the south side of the Schuylkill River was shown to be in alluvial deposits to slightly weathered, strong, hard dolomite. The microtunnel drive was expected to start out in a full face of alluvial deposits then transition into a full face of rock under the river which resulted in both a mixed face and mixed reach tunnel alignment. Twelve (12) soil borings were taken along the 436 foot tunnel alignment from the jacking to the receiving shaft. There were nine (9) within the banks of the Schuylkill River alone. Therefore, soil borings were spaced approximately every 40 feet. In spite of this substantial effort, top of rock requiring mechanical excavation was actually found up to 12 feet higher than expected at the jacking shaft and in the first half of the microtunnel drive. The mixed face transition zone where the ground was expected to change from alluvial soils to full face rock was considerably longer as well. Obviously, attempting to create a profile of the rock elevation in weathered limestone and dolomite adjacent to and under a river is a very difficult undertaking even when a large number of soil borings are taken. Figure 3 below shows the rock profile at the shafts and microtunnel drive assumed at bid time (solid red line) versus the actual rock profile encountered during construction (dotted red line where it deviates).

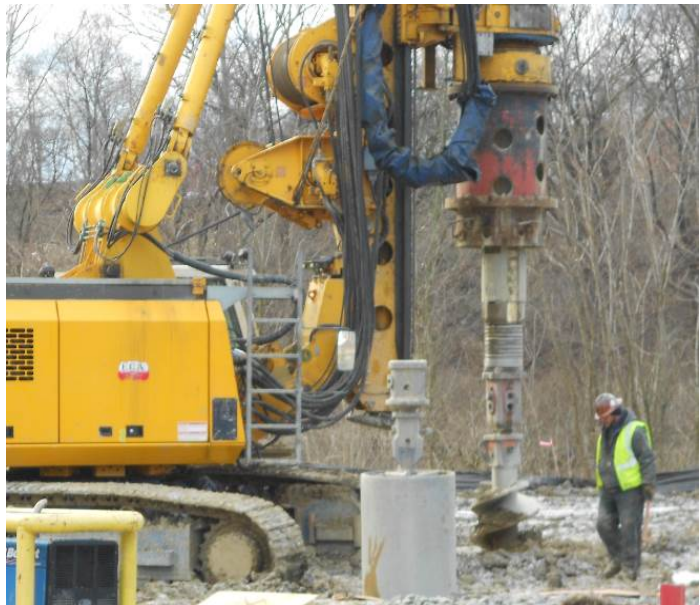
Figure 4: Secant Pile Drilling

Secant piles were designed to be drilled 15 feet below top of the invert tremie plug (see Figure 4). Excavation was planned as subaqueous. Once excavation was completed, a concrete tremie plug would be installed to resist hydrostatic uplift and the shaft would be pumped out and made ready for pipe jacking.

However, while drilling for the first secant pile, hard rock was encountered well above the level shown in the geologic report (see Figure 3 above). Substantial extra drilling efforts were required to reach the designed pile depth, resulting in work

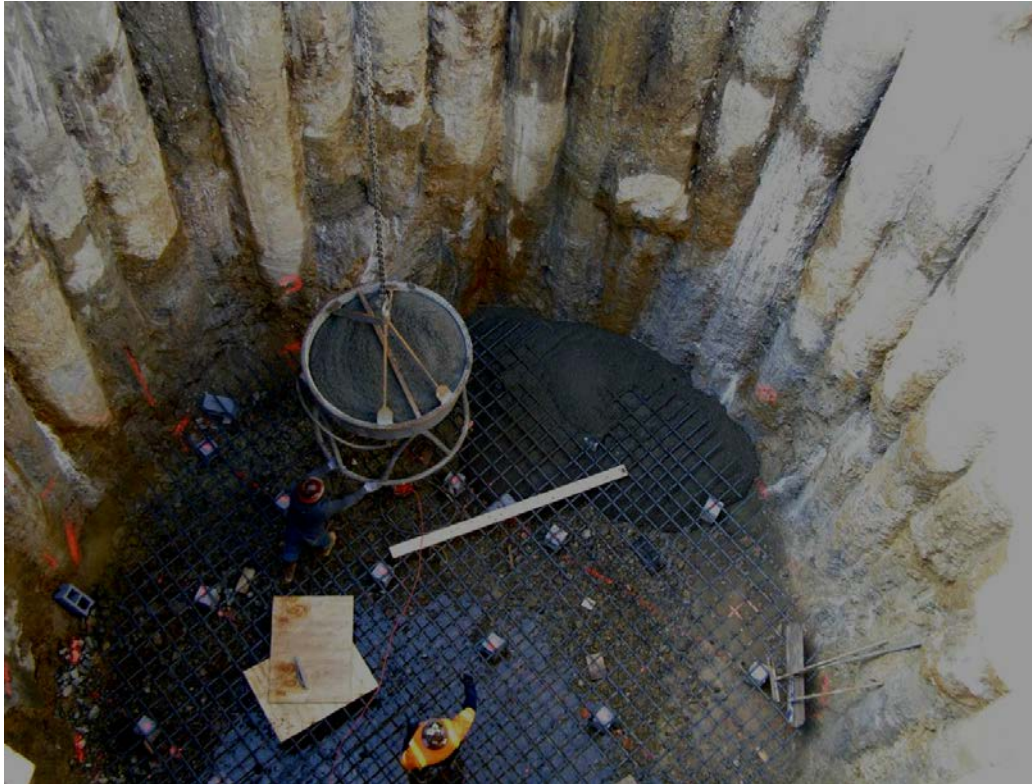
Figure 5: Secant Pile Shaft Invert Pour

durations that took twice as long as anticipated with extraordinary equipment wear and tear. Once the secant piles were all in place, subaqueous shaft excavation was supposed to proceed, followed by sealing the shaft invert with a concrete tremie plug. However, given the obvious presence of hard rock much higher than shown, the plan was changed. A reinforced concrete slab to resist hydrostatic uplift was designed in place of the previously submitted tremie plug to minimize the amount of rock excavation necessary to secure the shaft invert (see Figure 5). Excavation had to be in the dry to allow for the removal of the rock by mechanical means (excavators with hydraulic hammers). This again took considerable extra effort and additional time.

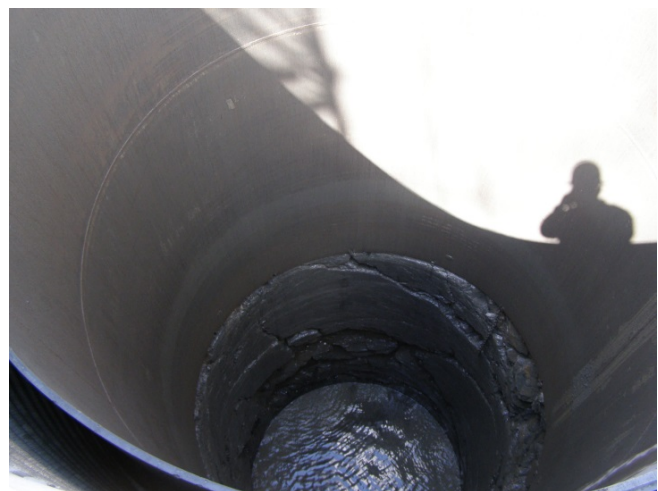
Figure 6: Drilling the Receiving Shaft

reasons. However, the hard dolomite (peak UCS = 34,300 psi) limited drilling the shaft to a finished diameter of 9 feet (see Figure 6). Bradshaw's specialized 60 inch MTBM was capable of being recovered from this extremely limited diameter shaft. It was drilled using slurry and steel casing shaft supports installed to the full depth and grouted in place. While drilling the hard rock was slow, the shaft was installed to depth without incident.

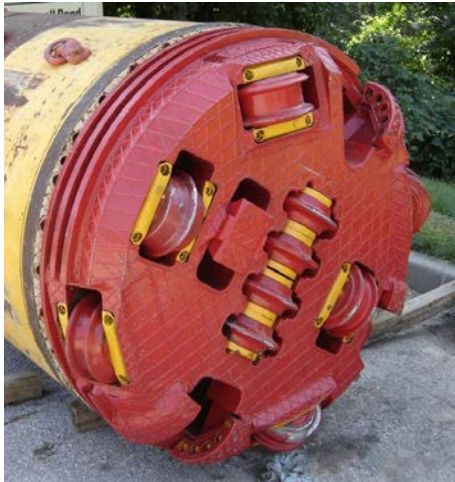
Figure 7: Rock Cutter Wheel

With the jacking and receiving shafts in place, preparations were made to begin the slurry microtunnel pipe jacking drive. First, a concrete entrance wall was formed and poured and an entrance seal attached. Next, a concrete thrust block was poured and a 520 metric ton jacking frame was set to line and grade. The specially fabricated 60 inch OD MTBM was configured with a rock cutter wheel using 280 mm disk cutters as shown in Figure 7.

The MTBM has an internal porthole to access the back of the cutter wheel. This allows cutting tool changes from within the MTBM during the microtunnel drive. This access is a critical requirement for any MTBM when microtunneling through hard rock. A telescopic tail can (telecan), which is essentially a recoverable intermediate jacking station (IJS), was fabricated by Bradshaw and installed behind the MTBM and trailing tube. The telecan was necessary to efficiently mine the rock portion of the drive and yet had to be recovered through the same 9 foot ID receiving shaft as the MTBM, so it too was specifically fabricated.

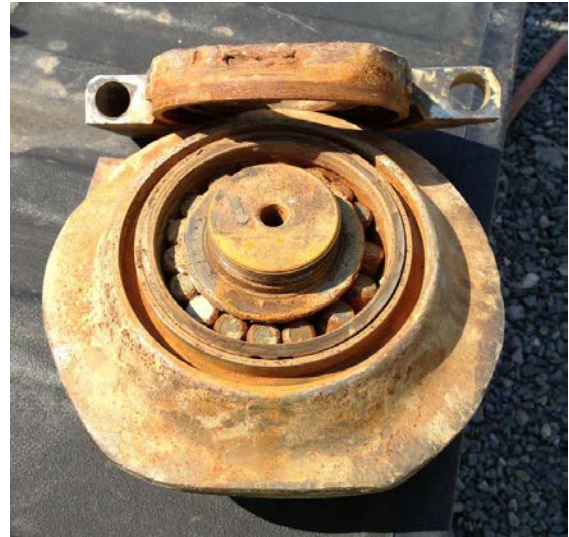
Figure 9: Disk Cutter with Bearing Failure

Rock microtunneling continued without incident until approximately 40 feet from the receiving shaft (nearly 400 feet into the drive). The MTBM ceased cutting and jacking pressures increased substantially. An intervention into the cutting chamber of the MTBM was necessary to determine if the MTBM cutting tools had been worn or damaged. Before attempting the intervention, the tunnel face was tested for water infiltration by disconnecting the return slurry line at the jacking shaft and opening the valve to the MTBM cutting chamber. Water was found to be free flowing into the cutterhead as if directly from the river above. We surmised the river water was in fact following the overcut annulus around the casing and into the cutterhead. This happened in spite of the use of extremely thick polymer bentonite lubricant and almost as thick bentonite drilling fluid (slurry). The only solution

- A slurry MTBM's ability to complete a drive in highly abrasive rock is normally limited by the wear of the perimeter gage disk cutter. In rock that has low abrasivity or is highly weathered, total drive length is often limited by potential failure of the face disk cutters. The face disk cutters have bearing covers on their sides that can wear rapidly in the slurry laden with rock cuttings. This leads to bearing exposure and failure, which prevents the disk cutter from turning. The disk cutter then wears away, creating a flat spot in the cutter kerf which eventually stops MTBM forward progress and requires disk cutter replacement to complete the drive. Therefore, access to the MTBM cutter wheel for tool changes is critical to successful rock microtunneling.

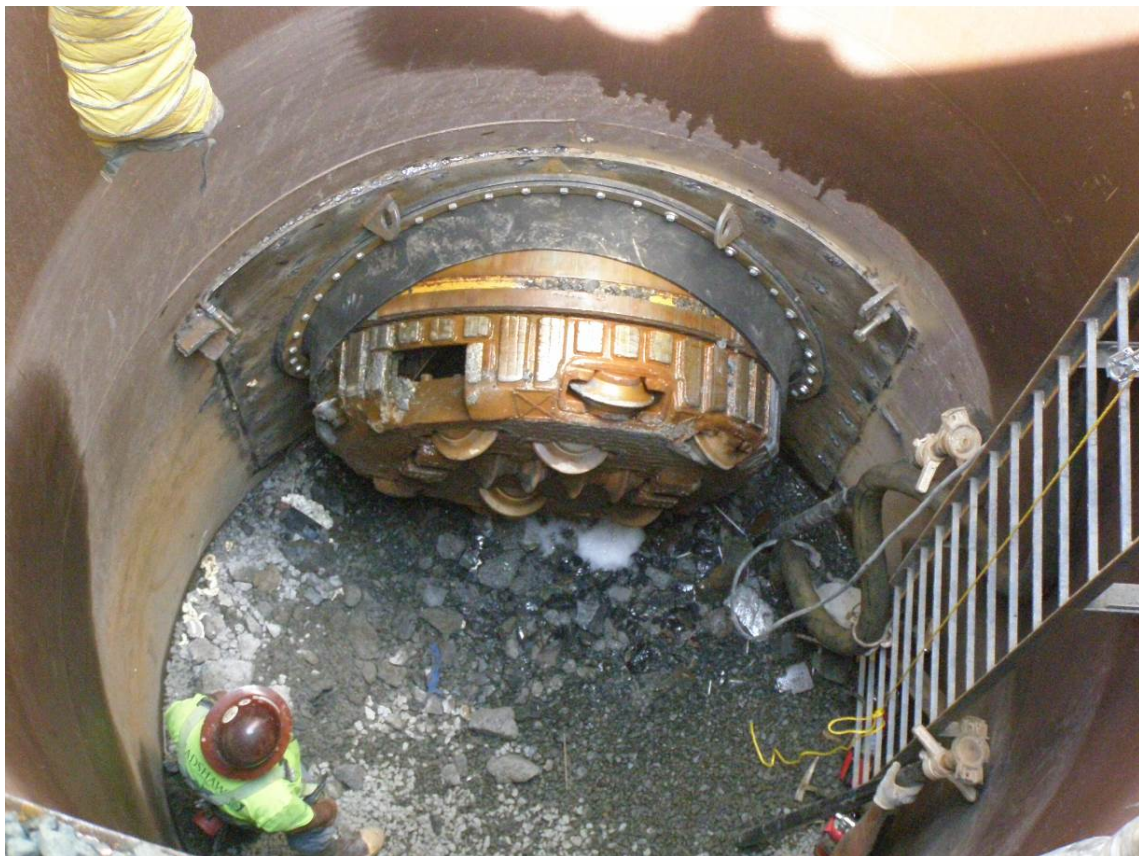
Figure 110: MTBM Recovery in 9' ID Caisson

While the full face of hard, strong dolomitic rock slowed our excavation rate, it did not present any MTBM steering challenges. In spite of concerns expressed somewhat jokingly by the Owner that we might miss the receiving shaft entirely, we actually hit the shaft dead center (See Figure 10). To minimize river water infiltration during MTBM recovery, grouting outside of the MTBM and casing was carried out again. Once the MTBM center was located, the receiving shaft steel casing wall was cut out and a rubber exit seal installed. The MTBM was jacked into the receiving shaft and disassembled into pieces and hoisted to the surface. The casing was jacked into its final position within specified alignment and grade tolerance, then contact grouted with an emphasis on the entrance and exit eyes to seal off river water infiltration.

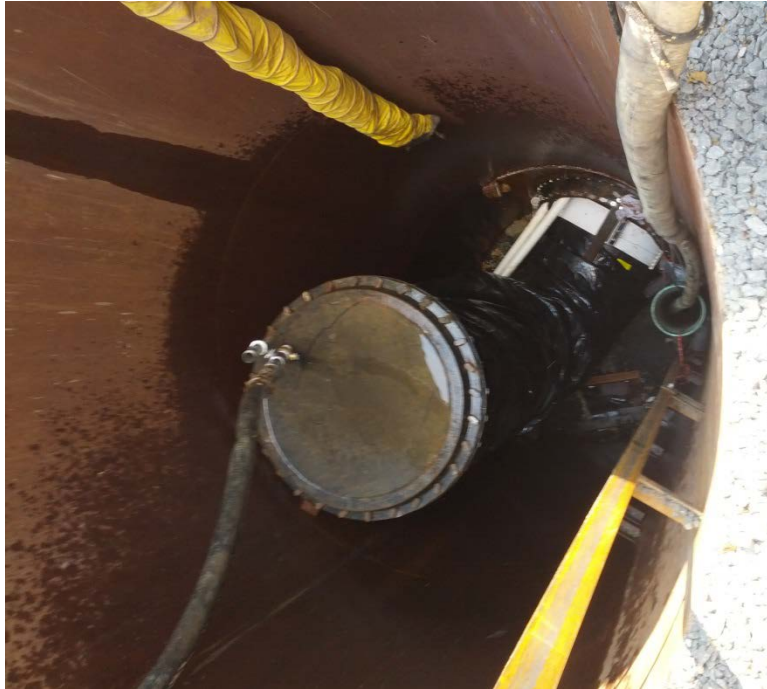
Figure 12: Force Main Carrier Pipe Testing

The force main carrier pipe was 42 inch DIP with restrained joints in 20 foot lengths. The DIP was jacked into the microtunneled 60 inch steel casing. Three (3) casing spacers were used to support each 20 foot joint of pipe. Once the pipe was installed and pressure tested (see Figure 11), the annular space between the pipe and the jacked steel casing was filled with a flyash grout, completing the microtunnel drive under the Schuylkill River.
