Project Profile: PIPE REHABILITATION

Claymount Avenue Sewer Repair
Baltimore, MD

PROJECT INFORMATION - 454

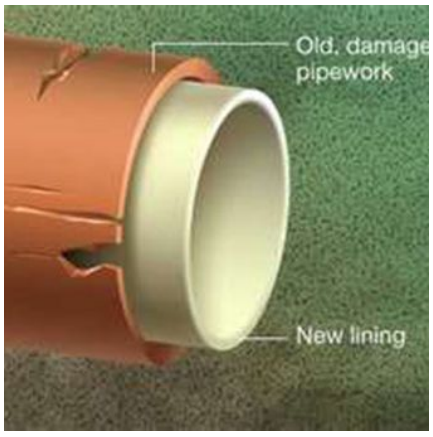
Bradshaw Construction was contracted by Baltimore city to perform an emergency repair and rehabilitation of a collapsed brick sewer causing sewage back-up and flooding in a residential area. Bradshaw excavated down and removed the damaged portion along with the top of the sewer. Then, 30" PVC slip-lining pipe was inserted into the sewer and pushed along the existing pipeline. When the entire length of slip-line pipe was installed the space between the new PVC pipe and the old deteriorated brick sewer was pumped full of grout so as to fill any voids. The major challenge of this project was that all the work needed to be completed without further restriction of the active sanitary sewer.
